CARBON CANAL COMPANY ASSESSMENT OF CANAL STRUCTURES

**Keller-Bliesner Engineering, LLC
78 East Center
Logan, UT 84321**

January 11, 2019

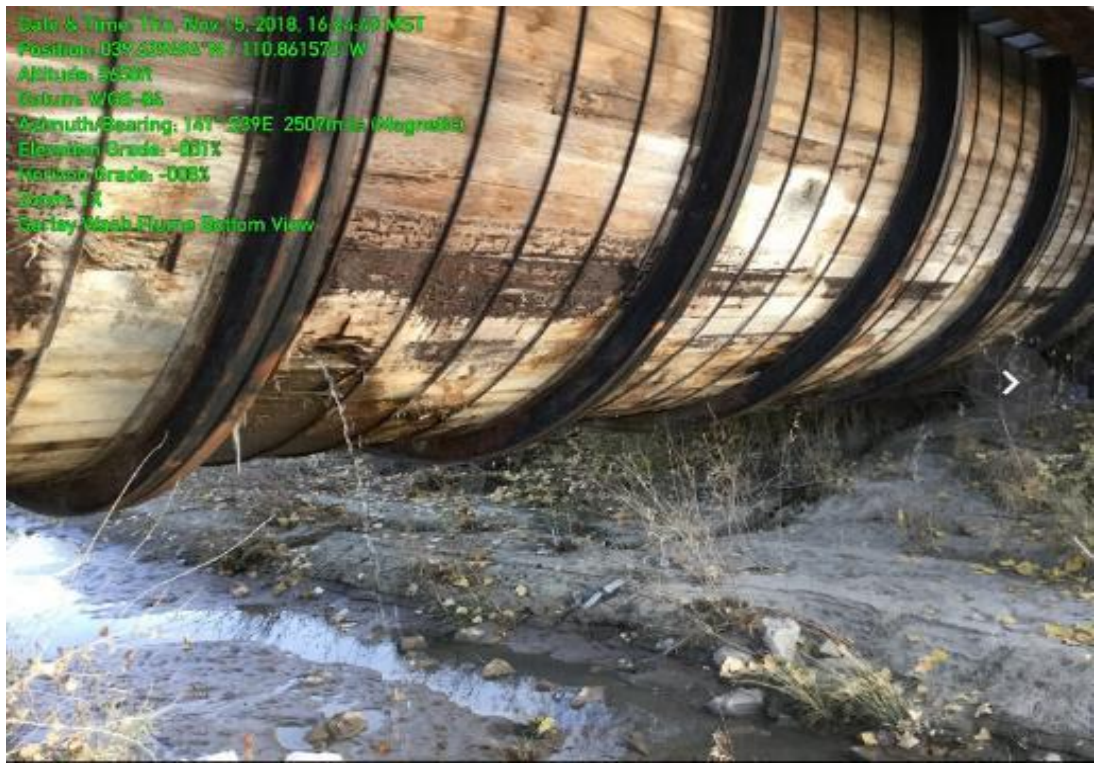
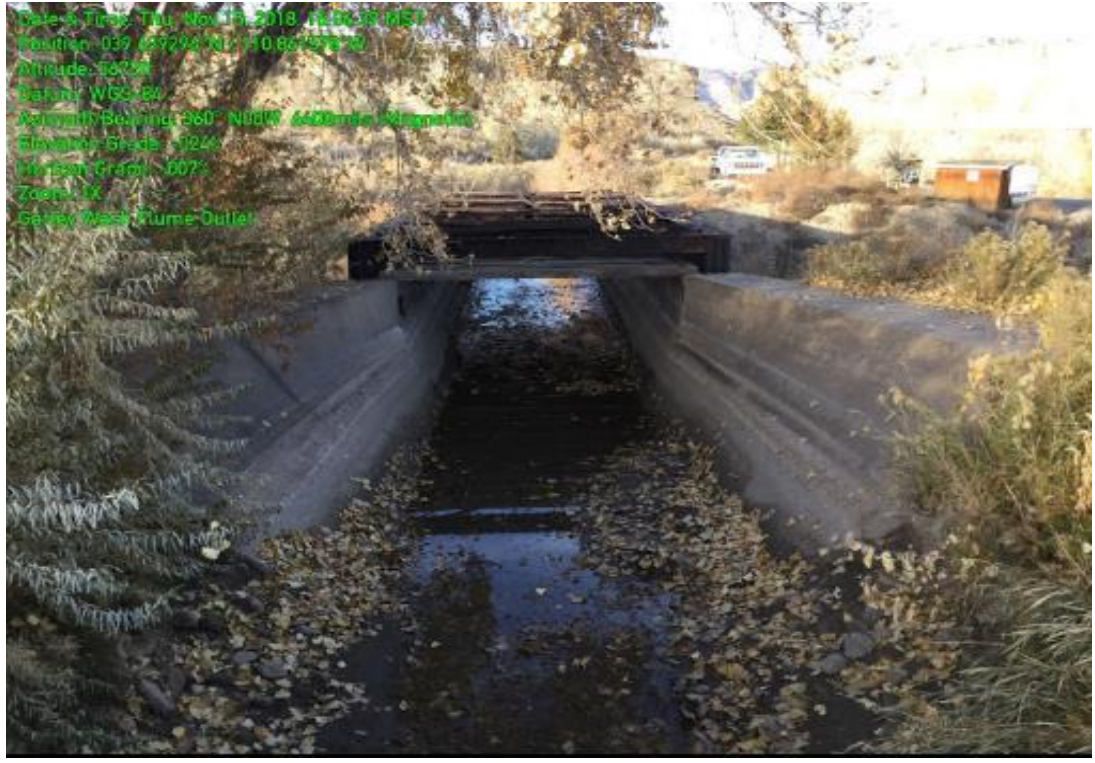
The Garley Wash flume is a 50-ft long semi-circular wood-stave flume with a 6.5 ft radius (Figures 2 and 3). It is suspended from a steel girder that spans the wash. The girder and concrete structures that support it are in excellent condition, although there is a good deal of surface rust on the steel.

The wood-stave flume is tensioned with 5/8-inch steel rods that pass through 3.5-inch by 5-inch wooden cross-members. The tension rods and cross-members are mostly in good condition. The leaking water has caused some rusting of the rods, but it is not severe. We identified three cross-members and rods that should be replaced.

There are 5 locations in the flume where the boards have warped, partially displaced or are broken. Otherwise, the wooden flume is in amazingly good condition for its age.

The biggest concern with this flume is the leakage. If the leakage continues, the tensioning rods will rust and eventually fail. We believe the best solution is to perform the repairs and line the flume with a 40-mil woven engineered geomembrane liner² with 8-oz geotextile backing or a 100 mil EPDM rubber liner. The budgets use the geomembrane liner as it is less expensive and is guaranteed for 20 years.

Figure 2. Garley Wash flume outside view

Figure 3. Garley Wash Flume inside view

The first task is to remove the 6 to 12-inches of sediment from the bottom of the flume. We recommend using a slip scraper and cable with a skid-steer loader to pull it through the flume. The flume would be pressure washed, especially at the connection points on the ends, to assure good bonding of the liner. After completing all repairs, the liner would be installed and fastened with stainless steel battens. The ends would be fastened to the concrete abutments with a gasket or sealant and stainless-steel bolts in concrete anchors. The sides would be bolted through the wood-stave flume to hold the lining in place.

The last recommended repair activity for this site is the excavation of the remaining sediment under the upstream end of the flume to increase the channel capacity under the flume. With these repairs, the flume is expected to last at least 20 more years. The total cost of the repair is estimated at about \$17,000 (rounded). The details of the cost estimate appear in Table 1. This is less than 10% of the replacement cost of the flume.

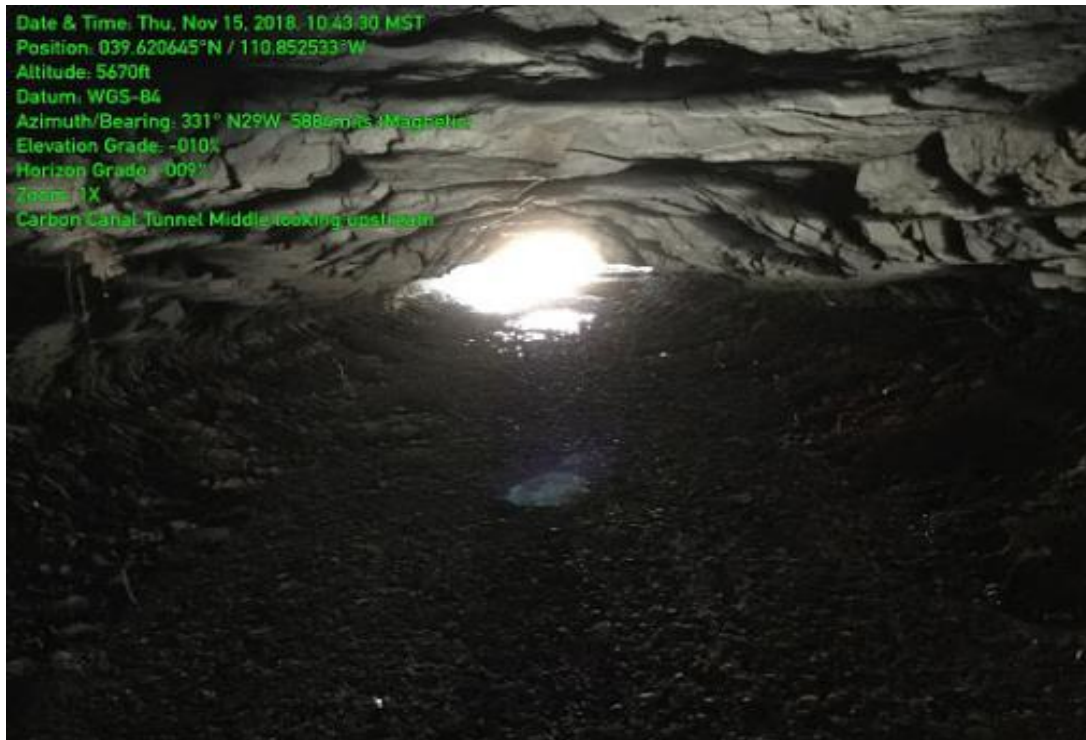
The 265-ft long tunnel was constructed in 1906 by excavation through Mancos shale (Figure 4). It is unlined and has likely eroded in width since construction due to weathering of the shale that was in contact with the water as it is now 22 to 27 ft wide and from 6 to 7 ft high (Figure 5). We could find no original dimensions, but it is unlikely that it was excavated that wide and there is evidence of shale slaking off the top as the tunnel has widened. There is adequate capacity and the top of the tunnel is not in contact with the water. The rock is competent in the ceiling, but the ceiling of the tunnel is very wide and flat, placing it at risk of further ceiling collapse. As it is located above all irrigation, a full tunnel collapse would cut off all water supply to the irrigated lands. The tunnel has up to 40 ft of over-burden and could take some time to clear if it collapsed during the irrigation season. A full collapse is not eminent, but continued slaking and partial blockage is a strong possibility. An earthquake would likely result in a total collapse.

Figure 5. Interior view of tunnel looking upstream. November 15, 2018

The least cost option is to line the tunnel with two 6-ft diameter HDPE Type S culverts, grouted in place. At \$321,000, it is \$73,000 or 18.5% less expensive than the multi-plate arch option. It has capacity to handle the maximum canal flow and is not subject to corrosion. The only downside for this option is the potential for trash accumulation at its inlet. No trash racks are required on these large pipes, but trash could become trapped between the two pipes, requiring periodic cleaning.

The multi-plate tunnel option has the best operational conditions with an expected life in excess of 60 years, but it still subject to corrosion with time. The corrosion can be mitigated by cleaning re-coating the exposed steel at 25-year intervals, extending the life to 100 years. At \$395,000 it is more expensive than the pipe option but does not have the limitation of trash accumulation at the entrance. If funding is available, it is the recommended option. If funding is limited, the piped option is an excellent second choice.

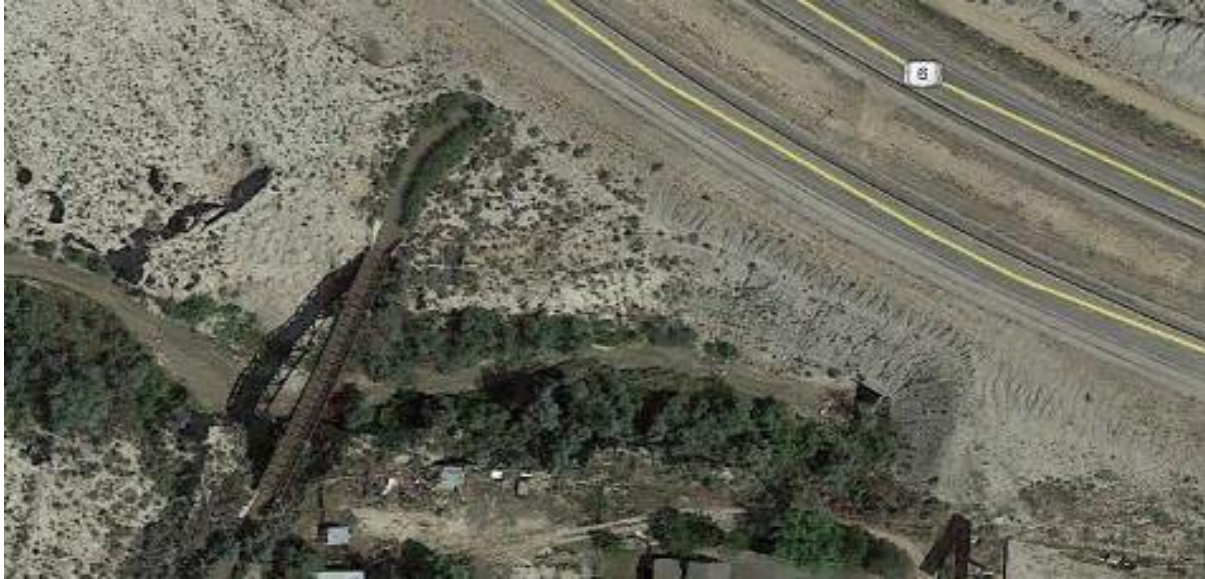
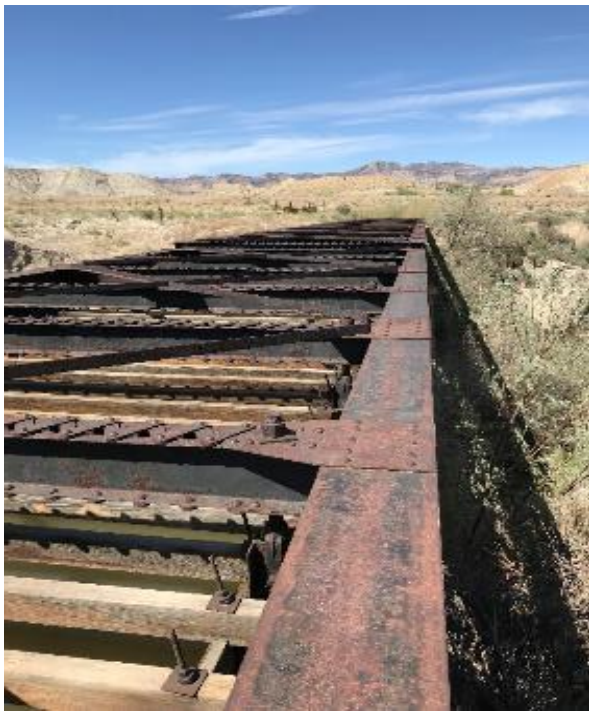
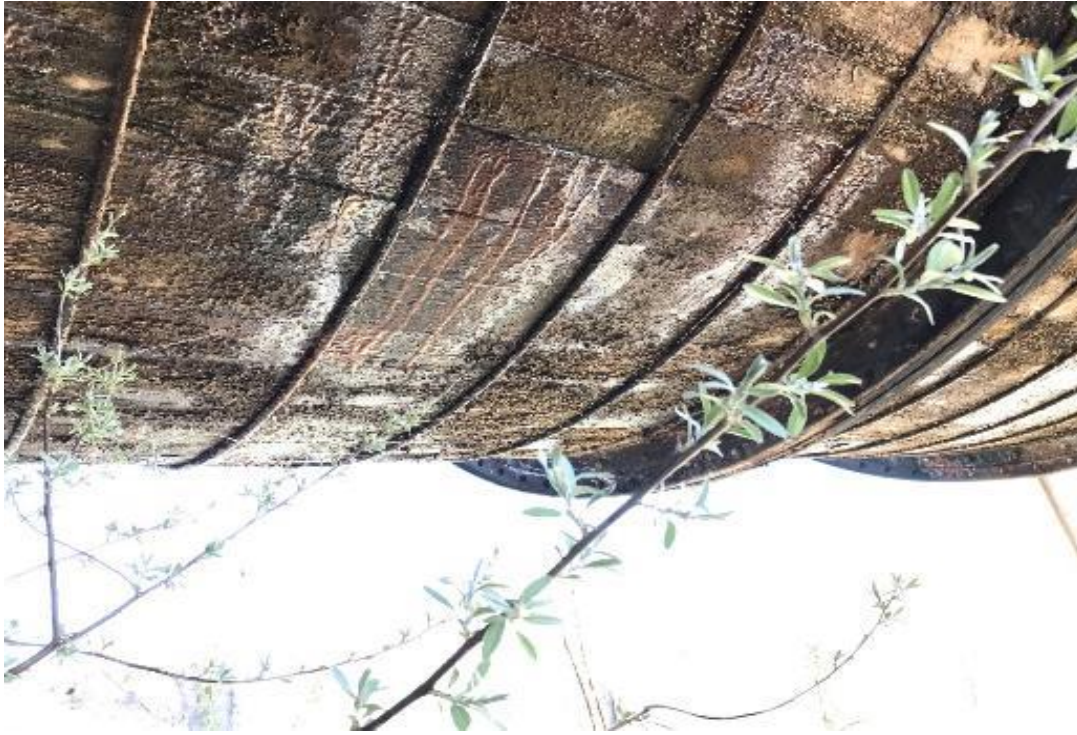
Figure 8. Aerial view of Gordon Creek flume

Figure 9. Gordon Creek flume showing girders and cross-braces

Figure 10. Closeup of wood-stave condition of Gordon Creek flume

The Gordon Creek flume is the same vintage (likely early 1940's) as the Garley wash flume, but it shows more deterioration. About 50% of the cross-braces are badly deteriorated and two were broken. Some of the tensioning rods have lost 50% of their thickness due to corrosion.

The condition of the overall structure is sufficient to warrant repair rather than replacement. The repair approach is the same as for Garley wash, only more of the cross members and tensioning rods require replacement. Sediment removal, cleaning, flume repair and lining would proceed as described for the Garley wash flume. In addition, we have added an estimate for placing grouted riprap along the south-side of Gordon Creek to protect the south pier.

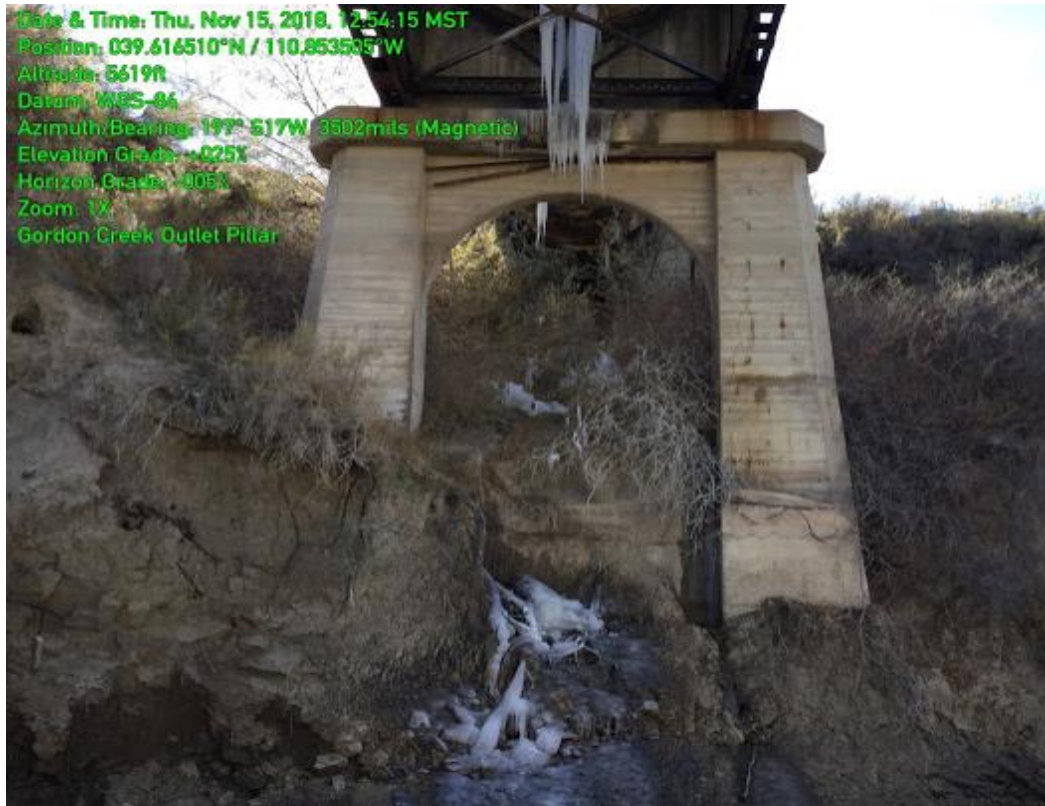
The concrete structures are in good condition, except stream erosion near the downstream pier risks undercutting the footings (Figure 11). Bank protection is needed in this area to prevent further erosion that could compromise the integrity of the structure.

Figure 11. Gordon Creek flume south pier showing stream channel erosion

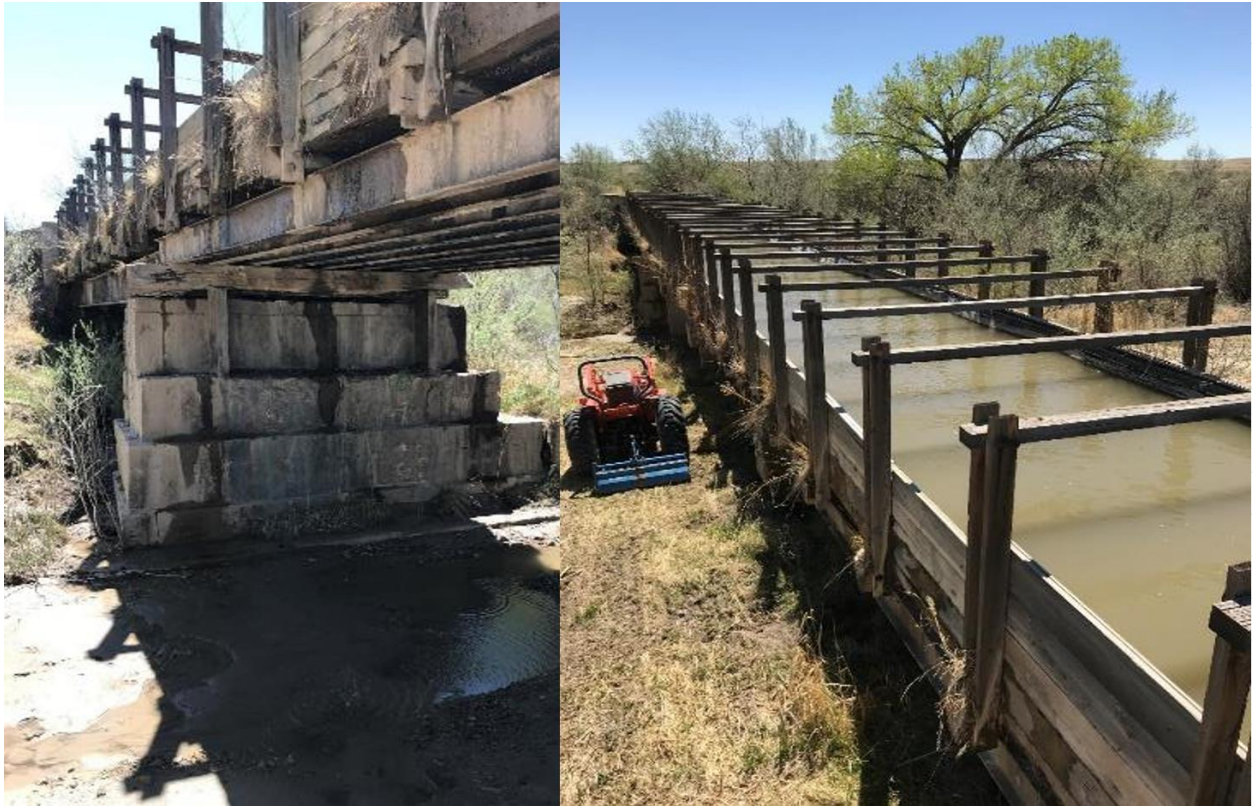
The Pinnacle wash flume is a 200-ft long rectangular wooden flume set on steel I-beams that are supported by concrete piers (Figure 12). The rectangular box is 13 ft wide with 3 ft sides. It has been replaced at least once. Records show that \$4,000 was borrowed in 1957 to raise the flume and replace abutments. There is evidence of other repairs, but it is not known when they were made.

This flume is in much worse condition than the Garley Wash or Gordon Creek flumes. The wooden flume has deteriorated and is leaking. Some of the steel I-beams are rusted completely through in the web. The concrete piers are deteriorating and the I-beams rest on wooden beams that are blocked up on one of the piers (Figure 12, left).

Figure 12. Pinnacle Wash flume

Unless funding can be identified for replacement in the winter of 2019-2020, we recommend performing the remedial repair and lining as soon as possible. The expenditure of \$17,000 will extend the life of the flume up to 5 years at 5% of the cost of replacement and protect the flume from failing.

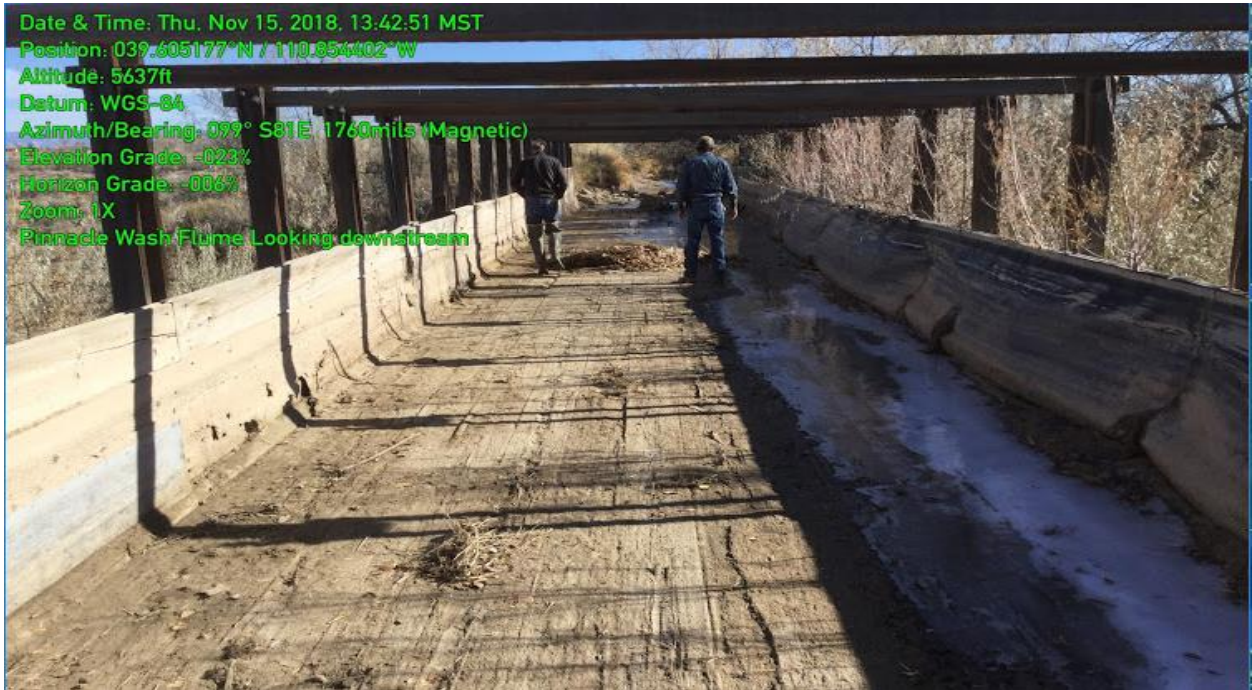
The sides of the flume have been lined in the past as some of the lining is still in place (Figure 13). The integrity of the liner is lost now. Given the overall condition of this flume, it is not expected to continue to function more than one more year without failure. By cleaning and lining the flume to stop the leakage and performing some remedial work on the piers, we believe the life could be extended up to 5 years while funds are sought to replace it. We estimate \$17,000 for the remedial work and lining as shown in Table 6. The flume should be monitored closely following repair and replaced within 5 years.

Figure 13. Inside condition of Pinnacle Wash flume

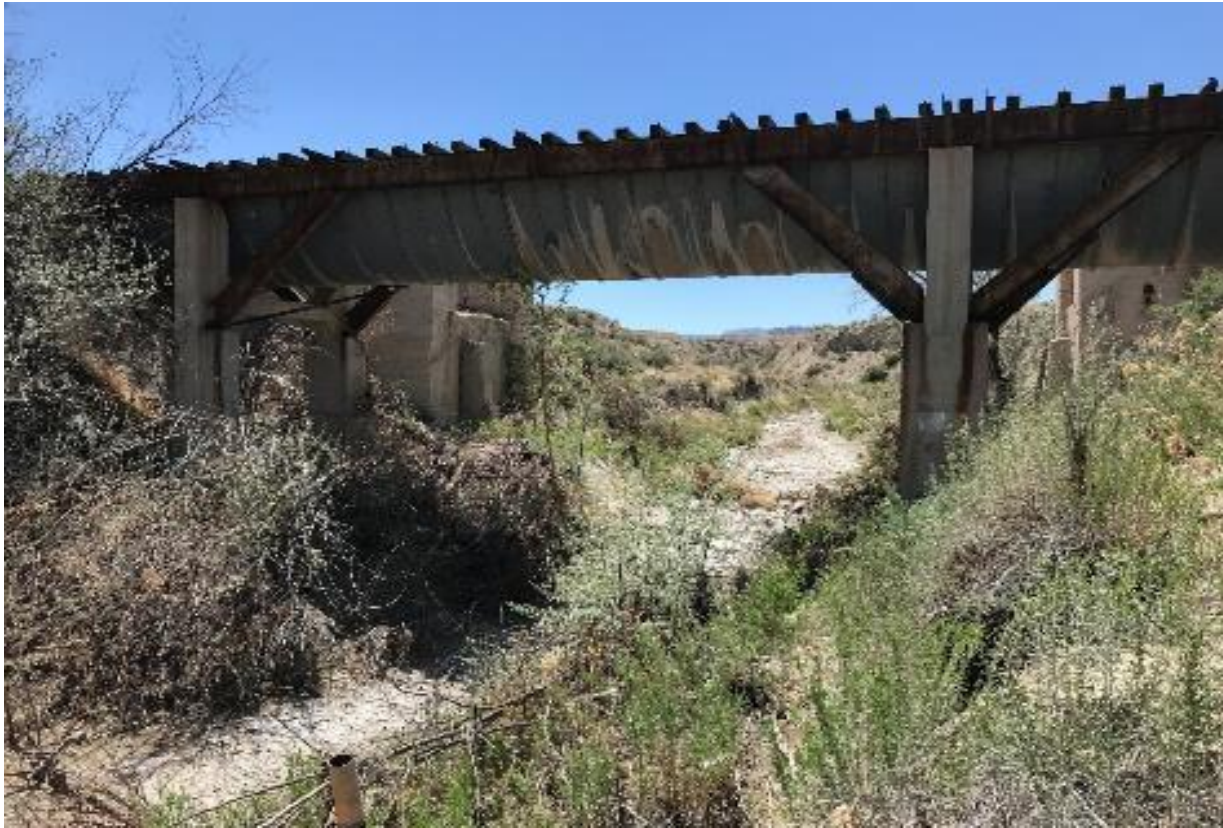
The Drunkard's wash flume was originally constructed in 1926 during realignment of the canal in this area. It was replaced or rebuilt in 1944 or 1945 with the present-day flume, consisting of a 5-ft radius semicircular Armco steel panel flume suspended from a steel I-beam support structure using tension rods and cross-members similar to a wood-stave flumes (Figure 16, 17). By 1968 the steel panels were rusting through and the flume was lined with fiberglass. About 3 or 4 years ago a portion of the flume was covered with a membrane liner because of excessive leakage near the downstream abutment. The remaining fiberglass liner is brittle and leaking and the membrane liner is developing some small holes.

Figure 16. Drunkard's Wash flume side view

Because the rehabilitation option is ½ the cost of the replacement option and will last nearly as long, it is the recommended option. The maintenance will be somewhat higher, but the total annual cost will still be substantially less than the replacement option.

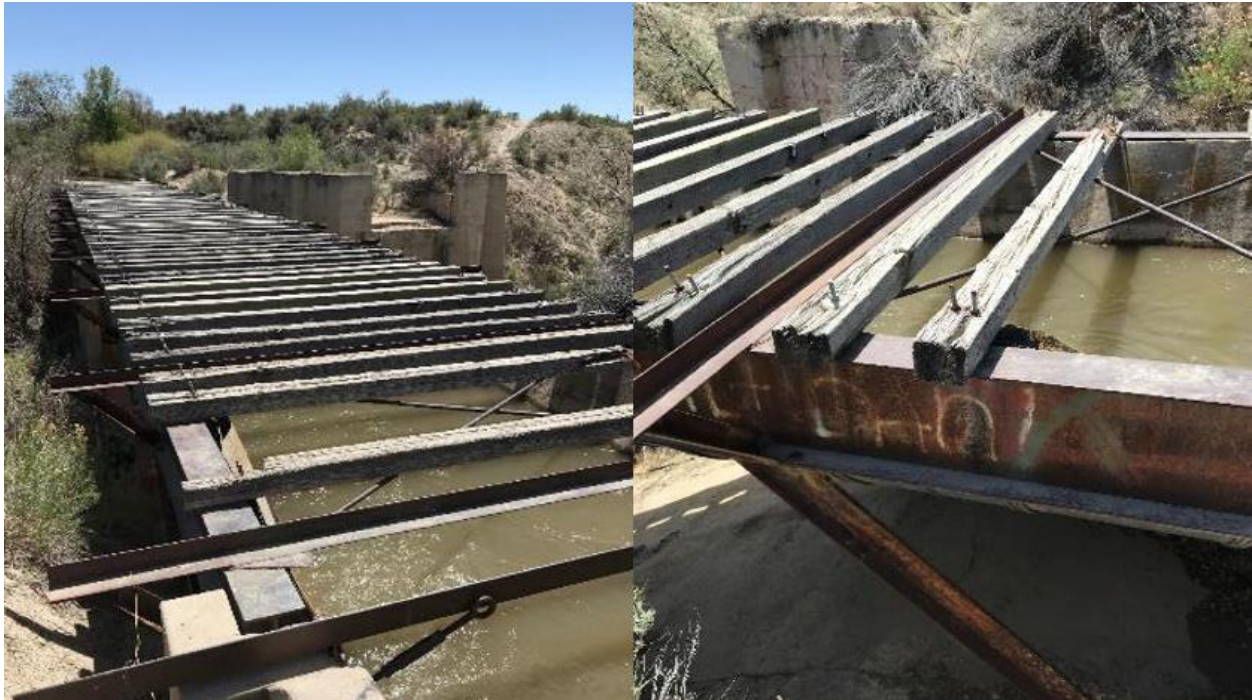
Figure 17. Drunkard's Wash flume top views

The concrete piers and abutment and the steel structure is in very good condition. The steel panels, cross-ties and support rods are in poor condition and must be replaced. We have examined two options for this location: (1) rehabilitation and (2) pipe flume replacement. An inverted siphon option would be difficult because of the steep slopes.

The rehabilitation option retains the concrete inlet and outlet structures, the concrete piers and the steel structures. As Figure 17 shows, the cross-ties must be replaced along with the Armco steel panels and many of the support rods. The best solution for replacement is to use multiplate semi-circular polymer-coated galvanized steel panels to replace the existing Armco panels. They would be suspended using 5/8" galvanized steel suspension rods bolted through the top flange of the steel I-beam supports with angle-iron cross ties for rigidity. The corrugated steel panels are inherently stronger than the flat-panel plates with less pressure on the steel rods. Salvagable rods will be reused.

After installation, the panel seams will be polymer-coated and any damage to the polymer coating on the panels repaired to seal the seams and protect the steel from corrosion. At each end, the transition from the steel panels to the concrete structures will be completed with geomembrane sheets attached with stainless-steel battens and gaskets or flexible sealant. This will allow the steel to expand and contract without leakage.

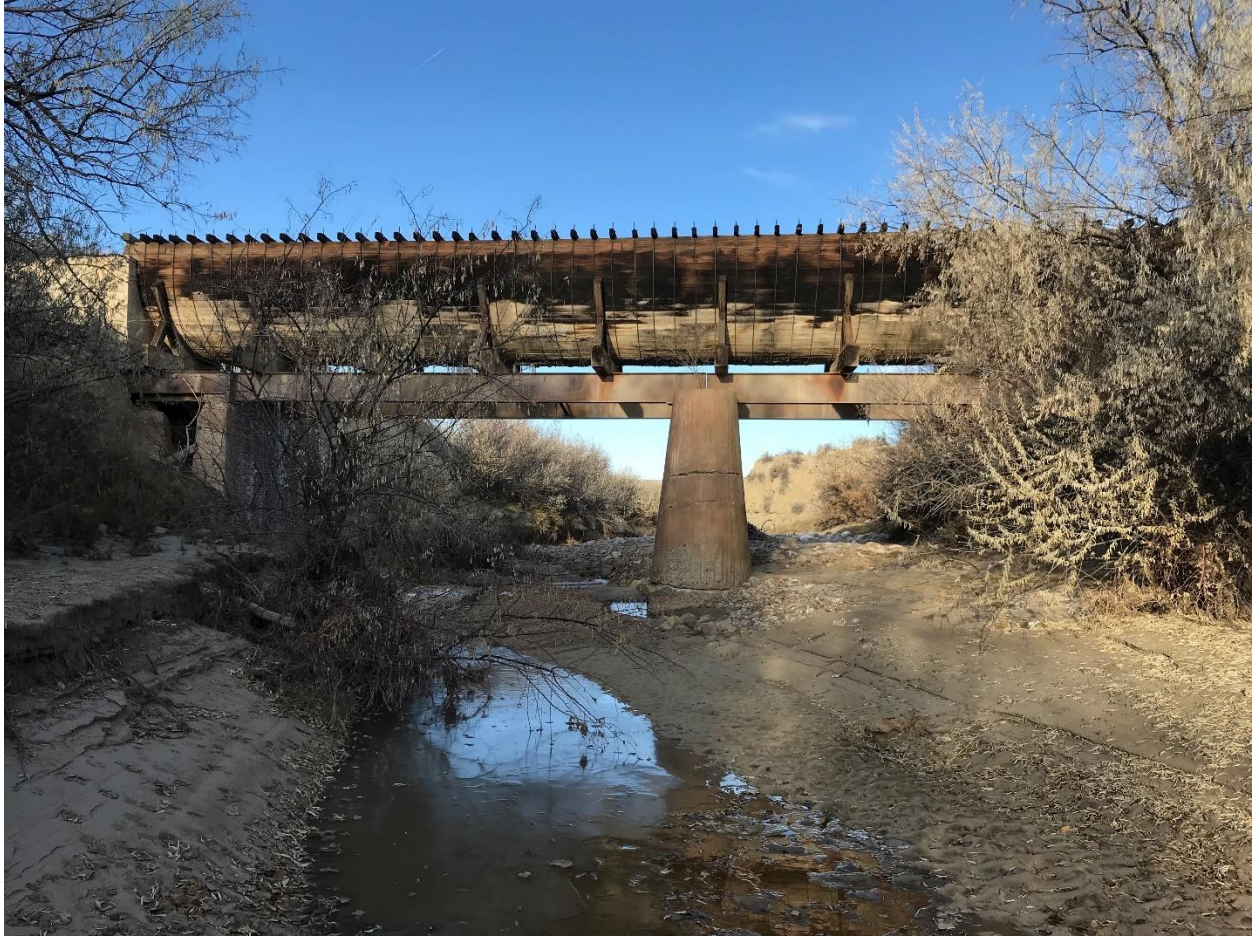
The existing 100 ft long Miller Creek Flume (124 ft long counting the two suspended concrete abutments) is the second flume at this location. It was constructed in 1937, just a few years before Garley Wash and Gordon Creek flumes. It consists of a 6.5-ft radius semi-circular wood-stave flume resting on wooden cribs (Figure 20). The cribs are supported by steel I-beams resting on concrete pillars. The entire structure is in poor condition. The greatest risk is a severely eroded concrete pillar on the downstream end (Figure 21). The erosion is caused by leakage and winter freeze-thaw damage. There is also leakage on the upstream abutment with eroded concrete and exposed and corroded rebar (Figure 22). The center concrete pillar is cracked with exposed and corroded rebar. The northern pillar is also cracked. The wooden structure is in reasonable condition, although it is leaking.

Figure 20. Miller Creek Flume looking west

After careful examination of this structure, we believe it can be rehabilitated for an additional life of approximately 20 years. The flume would be rehabilitated in the same manner as Garley Wash and Gordon Creek flumes by cleaning, repairing and lining with 40 mil woven geomembrane liner with an 8 oz geotextile back. The damaged cross-braces and tension rods would be replaced also. The wooden cribs are in excellent condition and do not require replacement.

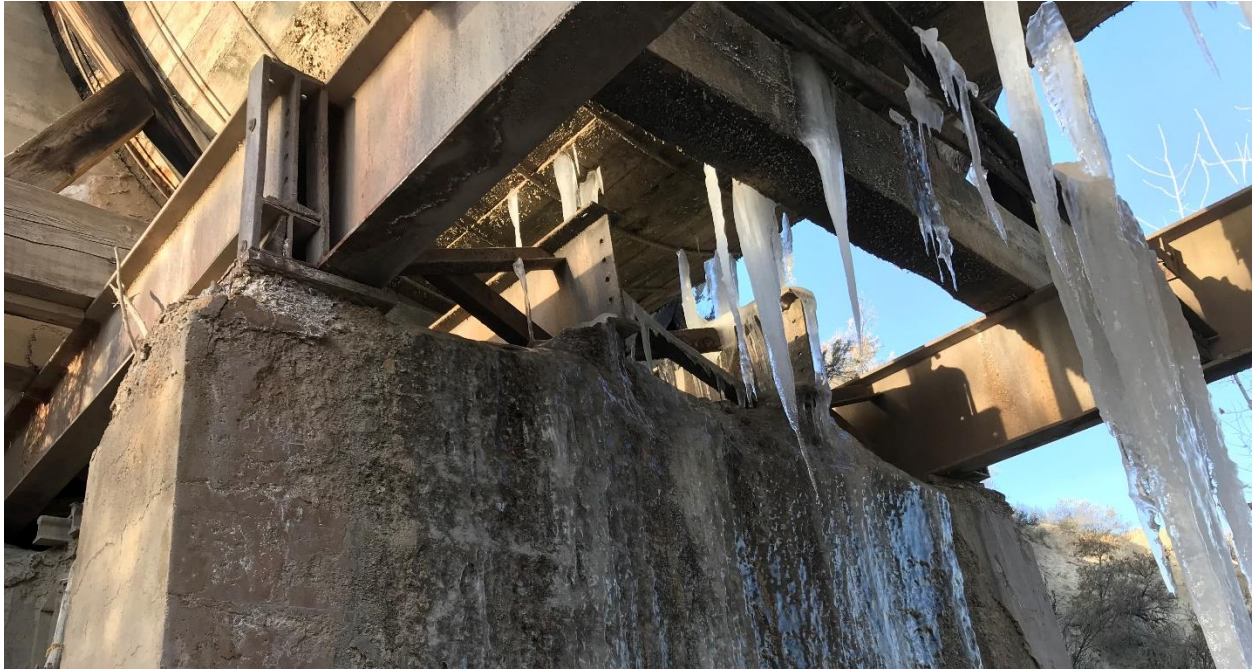
Figure 21. Miller Creek flume south pier showing concrete erosion

3. The Miller Creek southern pier could fail within 2 years if not repaired. Ideally its full rehabilitation should be funded in 2020 or 2021. At the very least the southern pier should be rebuilt no later than the fall of 2020. The entire reconstruction should not be extended past 2022.

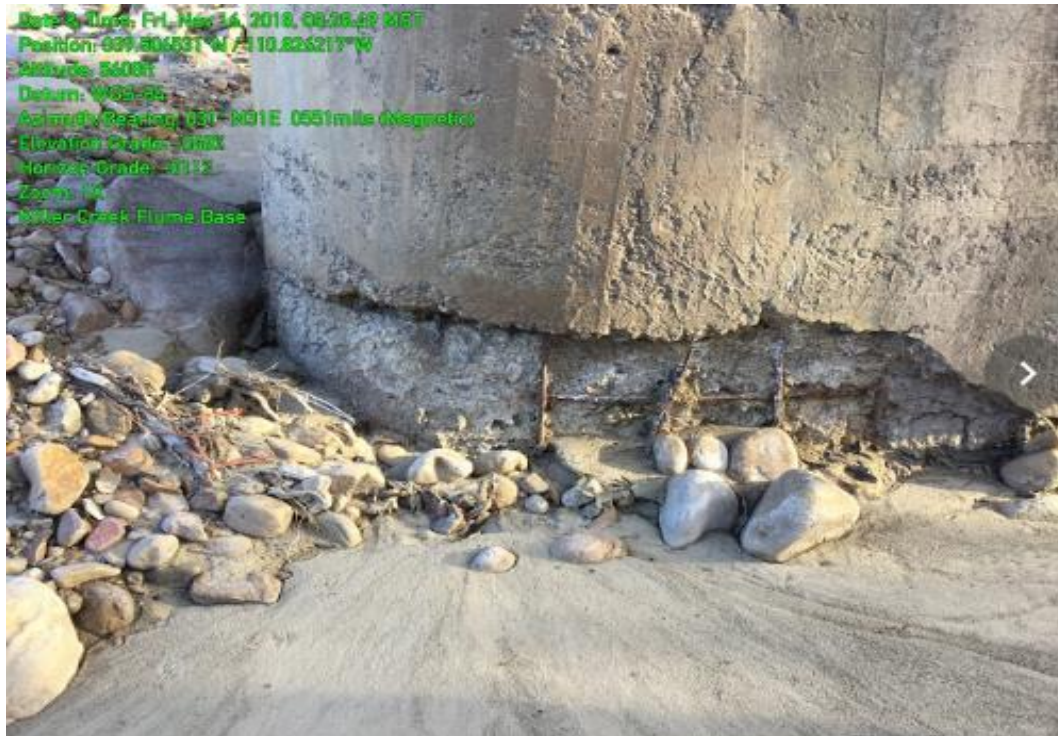
Figure 22. Miller Creek flume center pier with exposed and corroded rebar
