CARBON CANAL COMPANY ASSESSMENT OF CANAL STRUCTURES

**Keller-Bliesner Engineering, LLC
78 East Center
Logan, UT 84321**

January 11, 2019

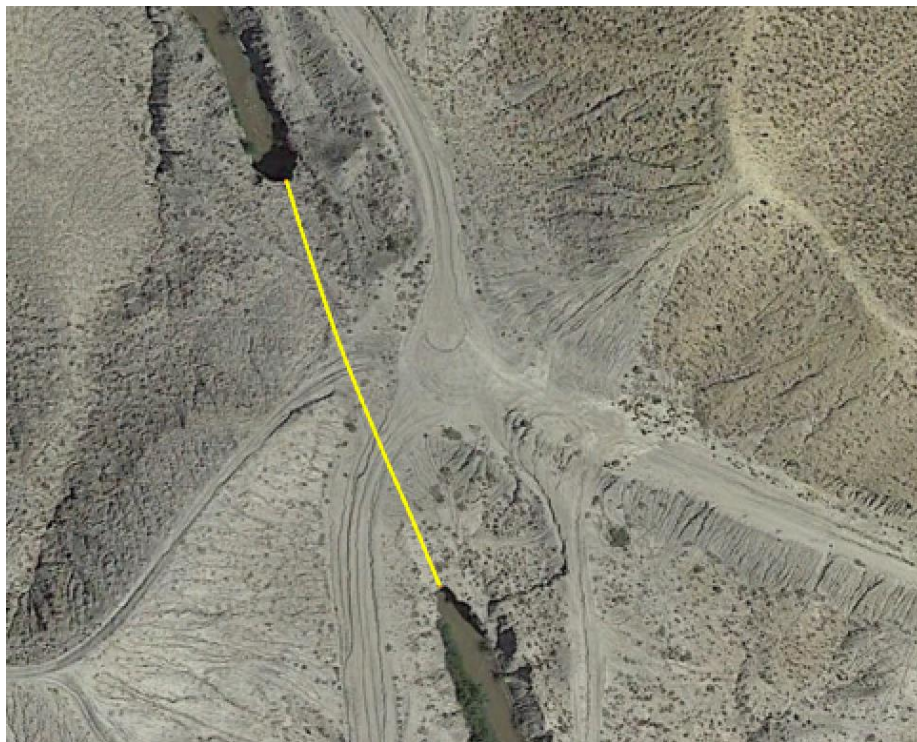
Figure 4. Tunnel alignment

The 265-ft long tunnel was constructed in 1906 by excavation through Mancos shale (Figure 4). It is unlined and has likely eroded in width since construction due to weathering of the shale that was in contact with the water as it is now 22 to 27 ft wide and from 6 to 7 ft high (Figure 5). We could find no original dimensions, but it is unlikely that it was excavated that wide and there is evidence of shale slaking off the top as the tunnel has widened. There is adequate capacity and the top of the tunnel is not in contact with the water. The rock is competent in the ceiling, but the ceiling of the tunnel is very wide and flat, placing it at risk of further ceiling collapse. As it is located above all irrigation, a full tunnel collapse would cut off all water supply to the irrigated lands. The tunnel has up to 40 ft of over-burden and could take some time to clear if it collapsed during the irrigation season. A full collapse is not eminent, but continued slaking and partial blockage is a strong possibility. An earthquake would likely result in a total collapse.
